Bartlemas: Introduction and location

Drainage work around the perimeter of St. Bartholomew's Chapel 2011 **Christopher Franks, Bartlemas Chapel Trust**

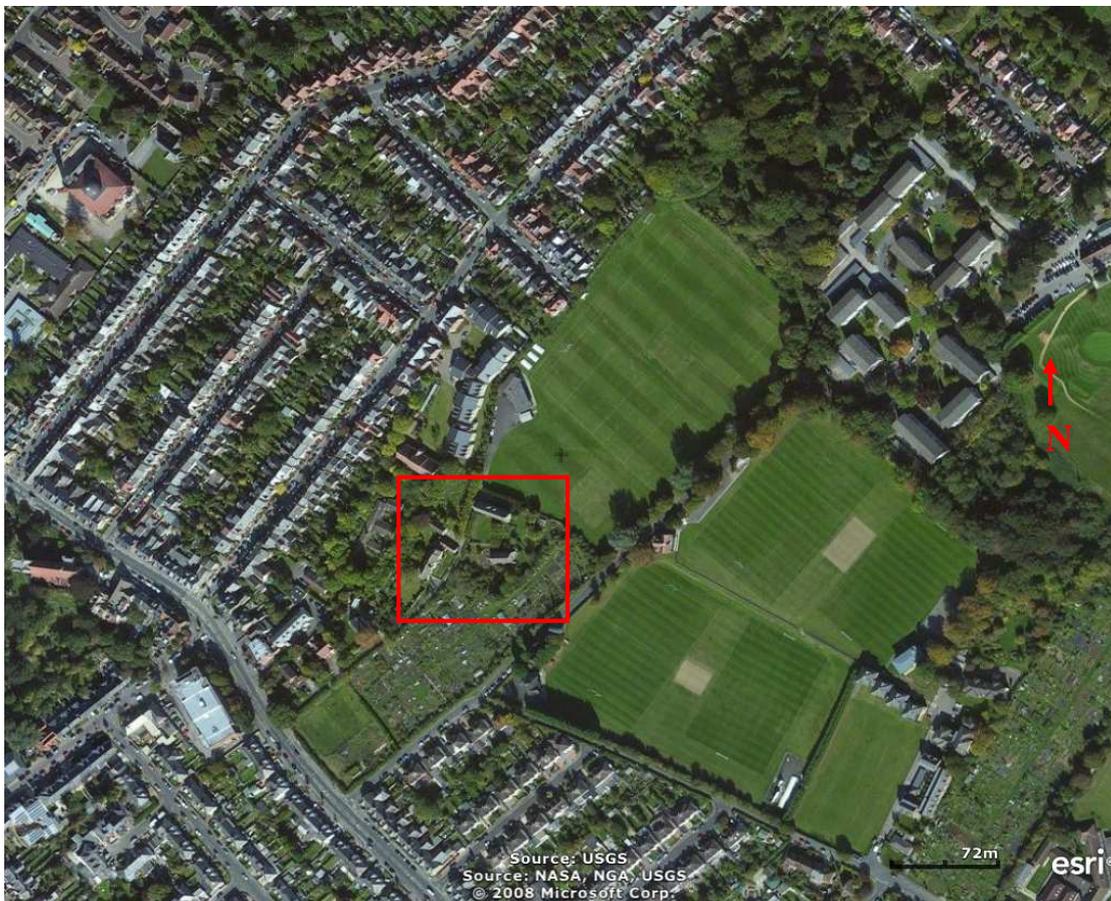
The excavation site: the red box surrounds the Chapel (centre), Bartlemas House to the North and Bartlemas farmhouse to the north

The Chapel site (see map above) lies at the foot of the ridge running NW-SE towards Church Cowley, the ground rising north-east towards Headington. The geology of the site is Oxford Clay of Upper Jurassic date but changes to the underlying fine-grained sandstones and siltstones of the Temple Cowley Member just over 300m to the NE of the Chapel site. This junction from permeable to impermeable geology creates a natural spring-line within the plantation at the top of the slope in the playing fields. A spring rise is visible in the northwest of these trees and feeds the ditch marking the western

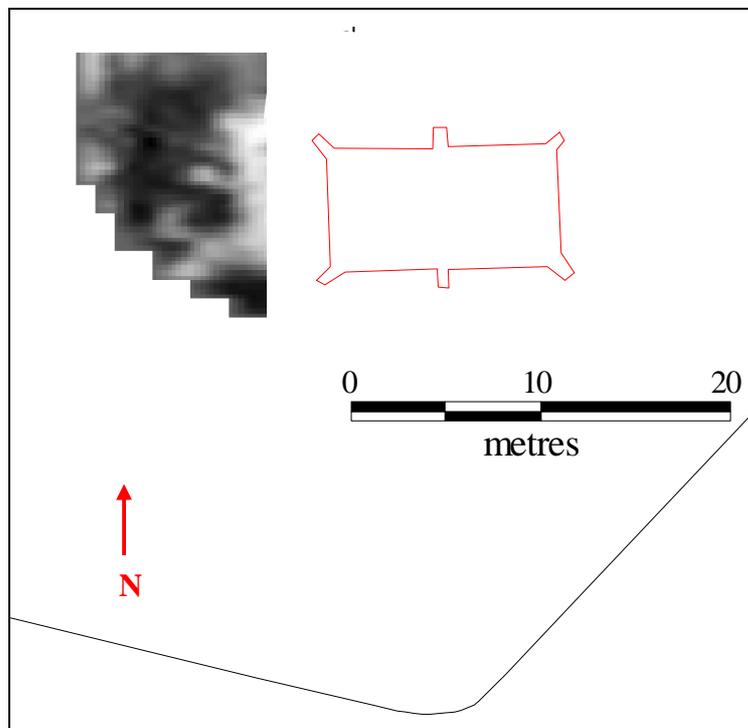
Bartlemas Chapel Resistivity: carried out by William Wintle and students of the Department for Continuing Education 2009

The immediate stimulus for the excavations was the need for remedial drainage work around the Chapel (see above) offering an opportunity to dig deeper by hand in small sections of the drainage trench excavated around the building. The Diocese of Oxford also granted permission for the Project to excavate over an area to the west of the Chapel investigated using geophysics (resistivity). Underlying this is the wider need for research into the medieval history of East Oxford.
