## Reflections on the excavation at Bartlemas

### Graham Jones

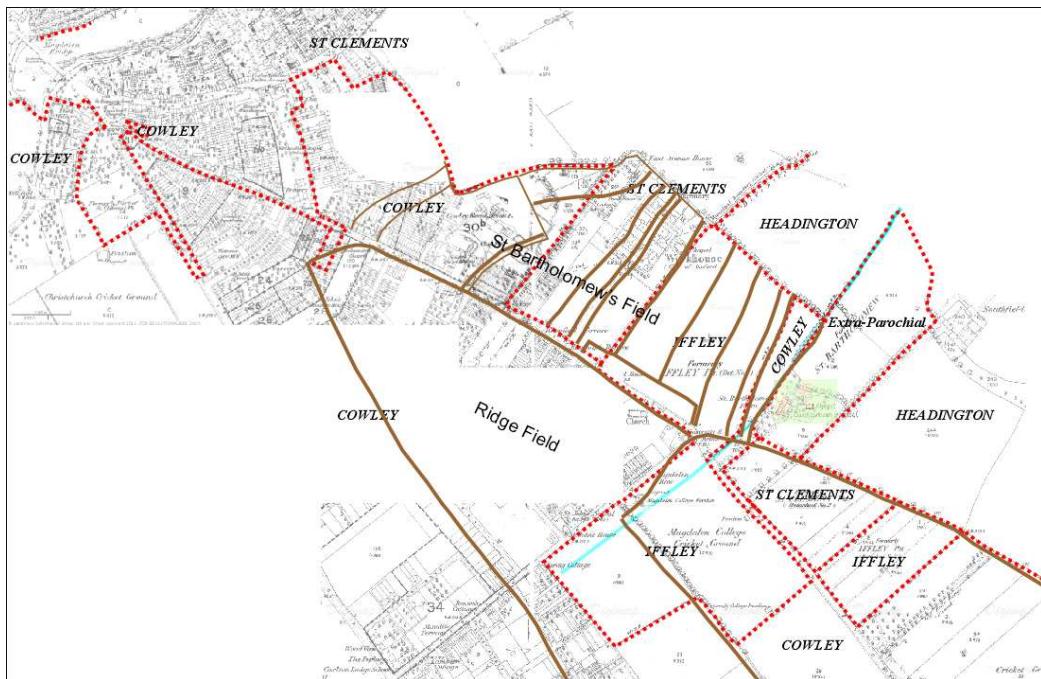
**Fig. 1** Open fields and parish boundaries, from OS 1:2500 maps, 1878, and select open field furlongs and strips shown on 'A Survey of an Estate belonging to the Dean and Canon of Christchurch lying in the Parish of Cowley in the County of Oxford, 1777'

Indeed, the six weeks left this digger with the feeling that water may prove to be a key element (*the* key element perhaps) in determining the location of this site and its functions as a hospital for the treatment of leprosy. The importance of bathing for lepers is documented, and its ritual aspect is found in Leviticus.<sup>1</sup> In the immediate topography, 'marsh' as in Cowley Marsh, has the meaning in Old English *mersc* of 'well watered land'. As Margaret Gelling and Ann Cole noted, 'The common use of *mōr* and *mersc* as qualifiers in *tūn* names reflects the high value of wetland resources to early farmers.'<sup>2</sup> In the absence of early forms, my guess is that the Strowell at Bartlemas (ceremonially garlanded every year, according to the seventeenth-century antiquarian Anthony Wood<sup>3</sup>) signified a spring in *strōd*, an Old English term generally taken to signify 'marshy land overgrown with brushwood' (cf. Stroud, Gloucestershire).<sup>4</sup> These names need not be taken as indicating poor, peripheral land. St Bartholomew's Field, along the ridge between here and what is now Jeune Street, was a shared open field which gave rise to interdigitated portions of Headington, Iffley, Cowley, and St Clements parishes (Fig. 1) which survived into the late nineteenth century. This may have fossilised an area of intercommoning, which suggests that the land was desirable for particular uses. The underlying clay is certainly gluey, and readily stuck to the trowel when dried out. The topsoil, on the other hand, is dark and broke up easily. Isolated sherds of pottery on the site suggest manuring to some minor degree, so that some of the land at least was cultivated. Indeed, as Fig. 1 shows, aratral curves (the S-shaped open

field strip edges resulting from repeated turning of the plough) come up to and define the western boundary of St Bartholomew's.

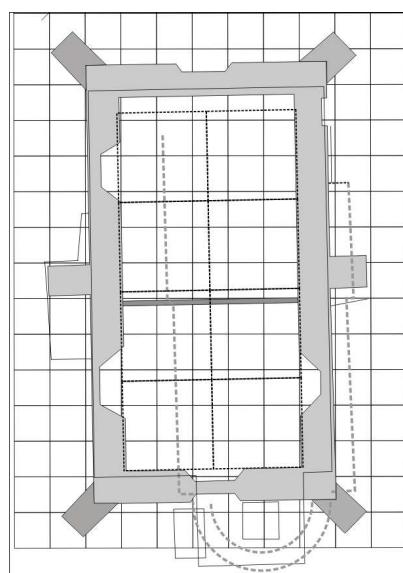
**Fig. 2** Conjectured apsidal end centred on mortar floor and defining the northern edge of the grave of Skeleton 1 (drawn by the author)

I went as far as testing to my satisfaction with a computerised drawing that an apse could return within the space between the burial (just south of the centre of the east window) and the north-east buttress, on the south side of which the land surface of the first day continued and deepened (Fig. 2). The buttress is poorly underpinned by rubble on this side, and I entertained the idea that some larger stones in the hard surface might represent some indication of the apse's return.

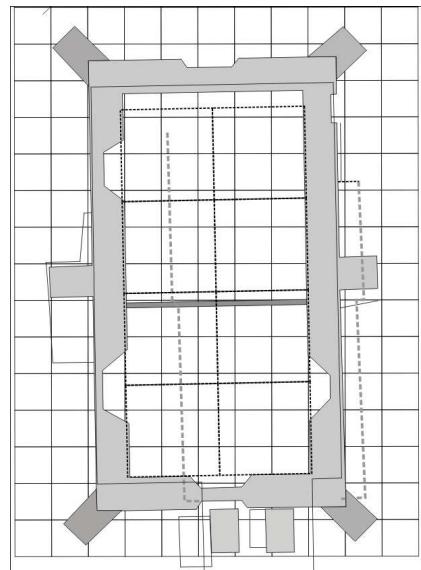
*Fig. 3 Structural masonry and mortar at the east end of the chapel (shaded) (drawn by the author)*

The burial recorded and sampled, I was able to return to this area on the last day of the dig before back-filling in the hope that hacking down through the stony surface would vindicate the thesis. I was disappointed. The surface gave way to a sandy spread beneath it, and below that, pea-grit. Intriguingly, the sandy spread ran away under the buttress's under-pinning. There was no sign of anything structural, however. Instead, under the pea-grit there was clay – thick, glutinous stuff that felt and looked like natural. However, a fellow volunteer, Karen, came to join me, specifically to continue digging out the clay fill of a construction trench around the chapel – a feature which had come to light much earlier and whose removal showed it dying away in the southern angle of the buttress. At the bottom of the trench she came upon a large, flat limestone block and a large lump of mortar (perhaps tumbled so that the stone to which it had been applied was upended and was now face down in the clay). In the fading light that evening, and together with Jane for an hour the next morning as the back-filling mechanical digger advanced towards us around the chapel, a mass of masonry and mortar became visible a short distance north of the first. No apse, this, but a small but well formed structure, either attached to, or against the east end of the chapel and cut through by the construction trench for the fourteenth century chapel (Fig. 3).

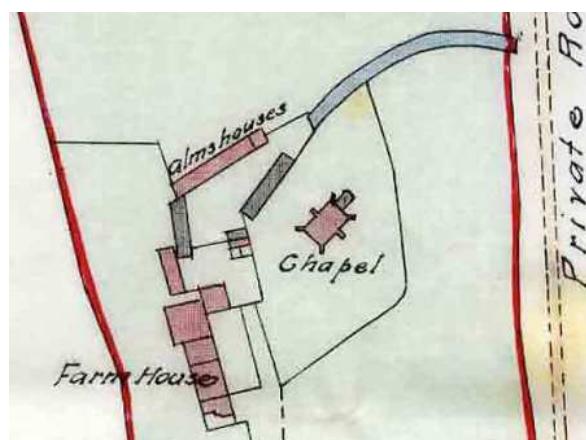
*Fig. 4 Water feature (coloured blue) shown on plan of Bartlemas Farm by Castle, Field & Castle, Oxford, June 8, 1837*

If this surface represents a path, where was its other end? One possibility is that it linked the chapel with the water feature shown on nineteenth-century maps (Fig. 4). This long, oddly curving feature might have been a fishpond, perhaps, but more likely in the context of the hospital is either a washing (i.e. laundry) pool or a place for the bathing of patients. Were inmates making their way from a bathing place to an east-end well house – or to venerate the relics? A well-house was incorporated at St Kenelm's, Romsley (Worcestershire), under the east end of the church (Figs 5 and 6). Here it seems that earlier a stream may have flowed from north-west of the church, through the nave and into the chancel. A damp area down the centre of the nave still caused problems in the 1990s. At Whitwell (Rutland) the eponymous 'white' or 'holy' spring rose west of the hilltop church (Fig. 8) and through

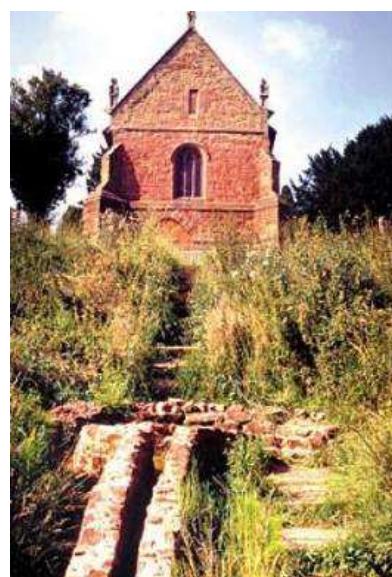
*Fig. 5 East end of St Kenelm's Church, Romsley, Worcestershire. Blocked-up archway giving access to wall-house beneath the east end of the church can just be seen. Brickwork in foreground is part of the landscaping of the present spring done in 1985.*

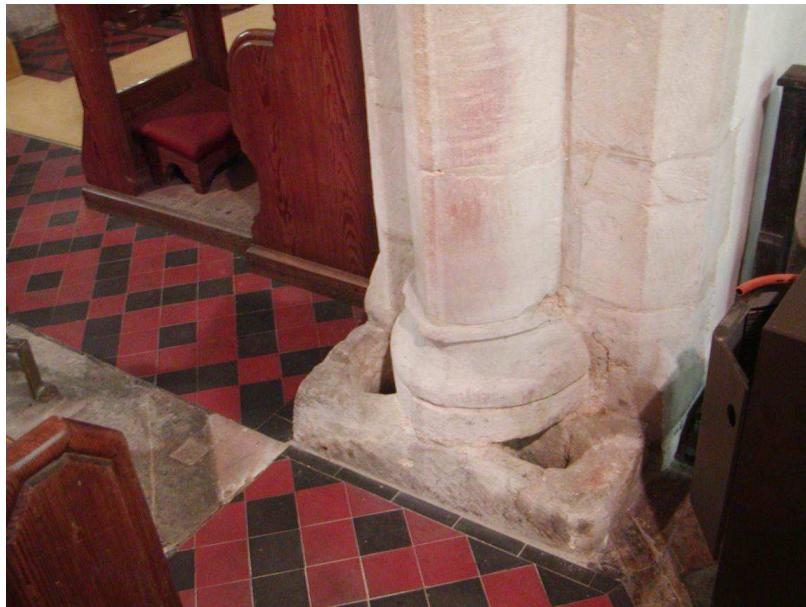
**Fig. 7** St Michael's, Whitwell, Rutland. Drainage base at foot of thirteenth-century chancel arch column

it, excess water being channelled away through drainage stones at the base of the chancel arch pillars (Fig. 7). St Bartholomew on the Tiber Island, the inspiration for St Bart's, Smithfield, and so at one remove for Bartlemas, has a spring head in the sanctuary steps (Fig. 9). St Gabriel's church, Nazareth, has a spring in a western annexe which is associated with the Annunciation. At Bartlemas, a fellow volunteer, Steve, noticed what could be the ghost of an arch in the east wall – though the wall may have been rebuilt at least once, as evidenced by the truncated string course between the corner buttresses. This prompts comparison with the door behind the high altar at Hallaton (Leicestershire) (Fig. 10), which gave access to spiral steps in a former external turret probably leading to an ostension (or monstrance) platform for displaying relics to the public. At Bartlemas the opening might possibly have been intended to allow the transfer of relics between their storage place and the main body of the chapel, or to give access from the chapel to a well-house, or for something else entirely.

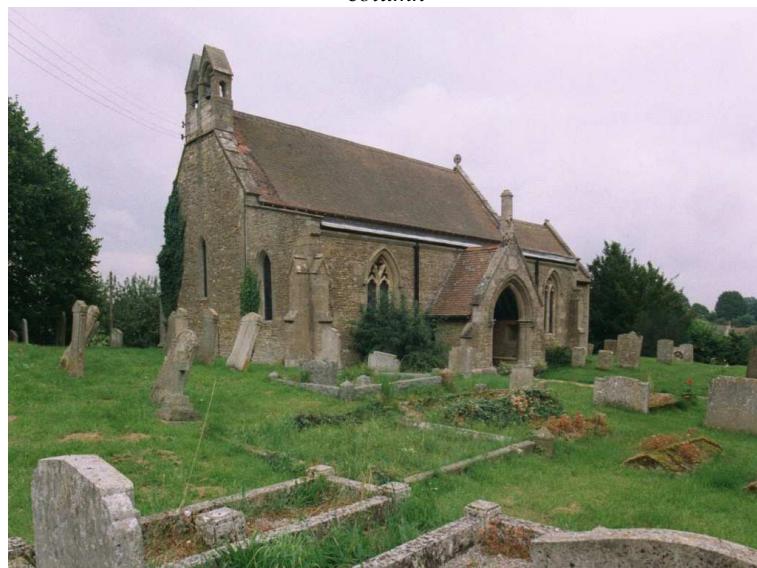
**Fig. 8** St Michael's, Whitwell, showing hilltop site and land falling away from the east end

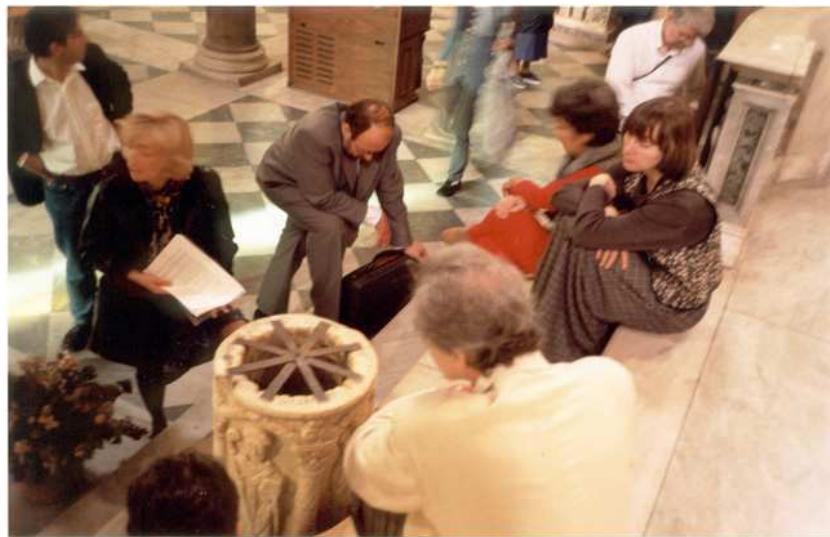
**Fig. 9** Romanesque sculptured spring-head in the sanctuary steps of St Bartholomew's on the Tiber Island, Rome

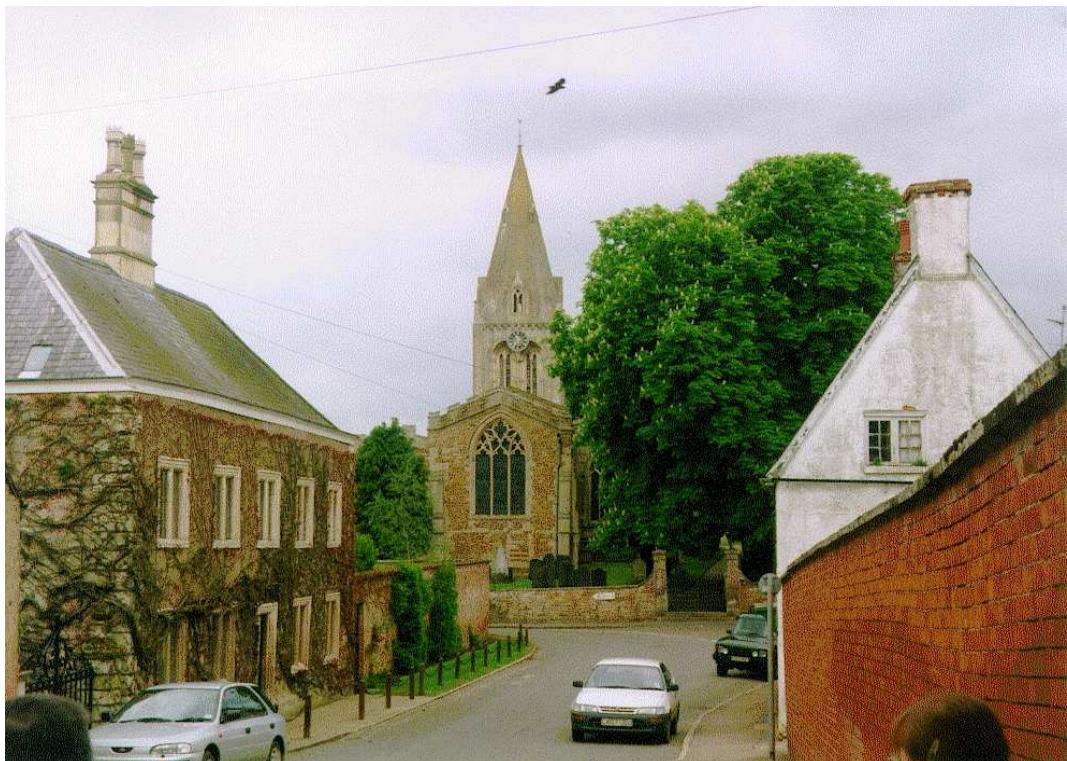
**Fig. 10** St Michael's, Hallaton The scar of the internal doorway giving access to spiral steps to an external turret and probable platform for displaying relics can be seen below the northern light of the east end window. Crowds gather in the open space in front of the church entrance for the scattering of hare pie before the start of the procession to the site of St Morrell's Chapel for the Easter Monday Bottle-Kicking
